EXECUTIVE SUMMARY

ABSTRACT

INTRODUCTION

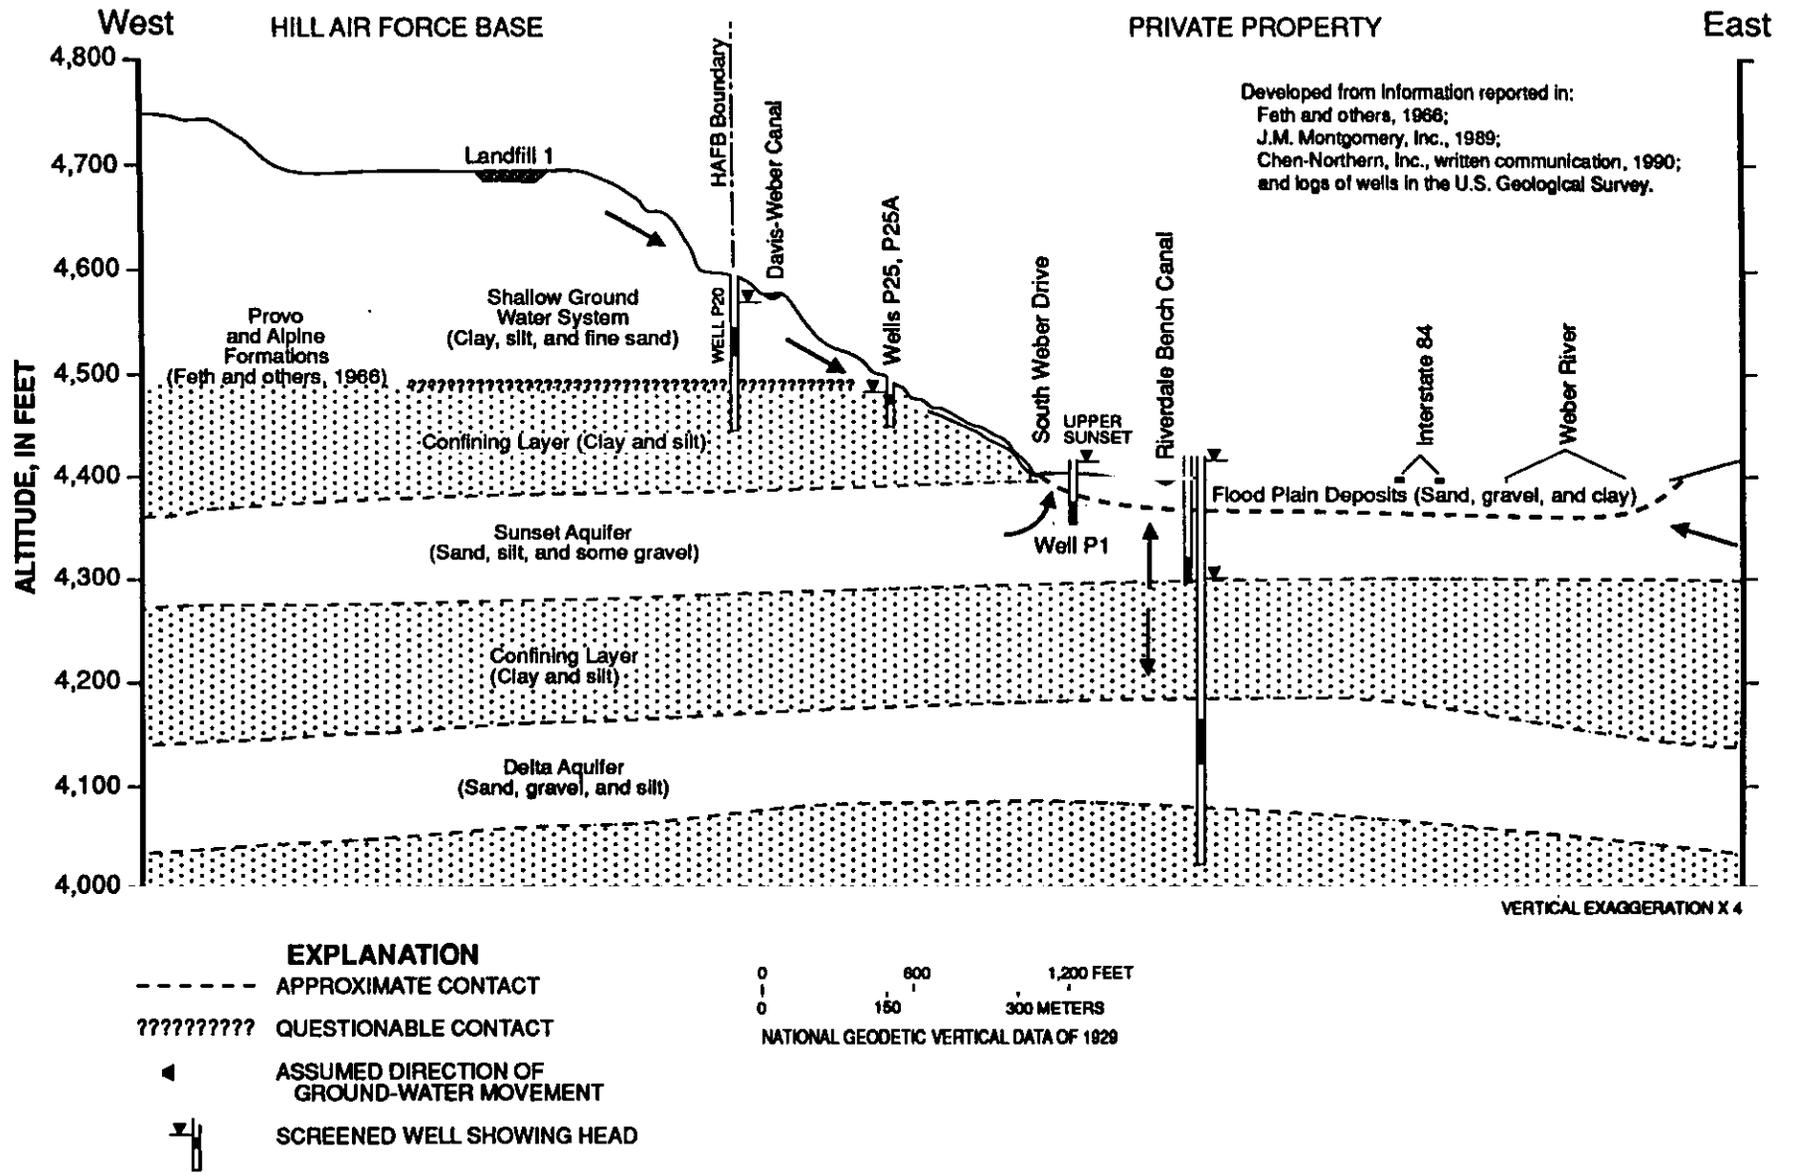
Figure ES-3.--Diagrammatic section of the probable relation between the shallow ground-water system in the area of Operable Unit 4, the flood-plain deposits of the Weber River, and the underlying regional confined aquifers.

Hill AFB overlies three aquifers (fig. ES-3). Two of the aquifers, the Sunset and the Delta, are productive sources of good quality water and are used by both Hill AFB and surrounding communities. Water in these aquifers generally is confined and occurs at depths of 300 and 600 ft below the landfills. Shallow ground water, in which contamination has been detected, overlies the Sunset and Delta aquifers.

Drilling in the vicinity of OU 4 into the Provo and Alpine Formations has shown that the lithologic character of the deposits is mainly clay with lesser quantities of silt and very fine sand (fig. ES-3). The lithologic character varies laterally and with depth, although not substantially in the first 60 ft.

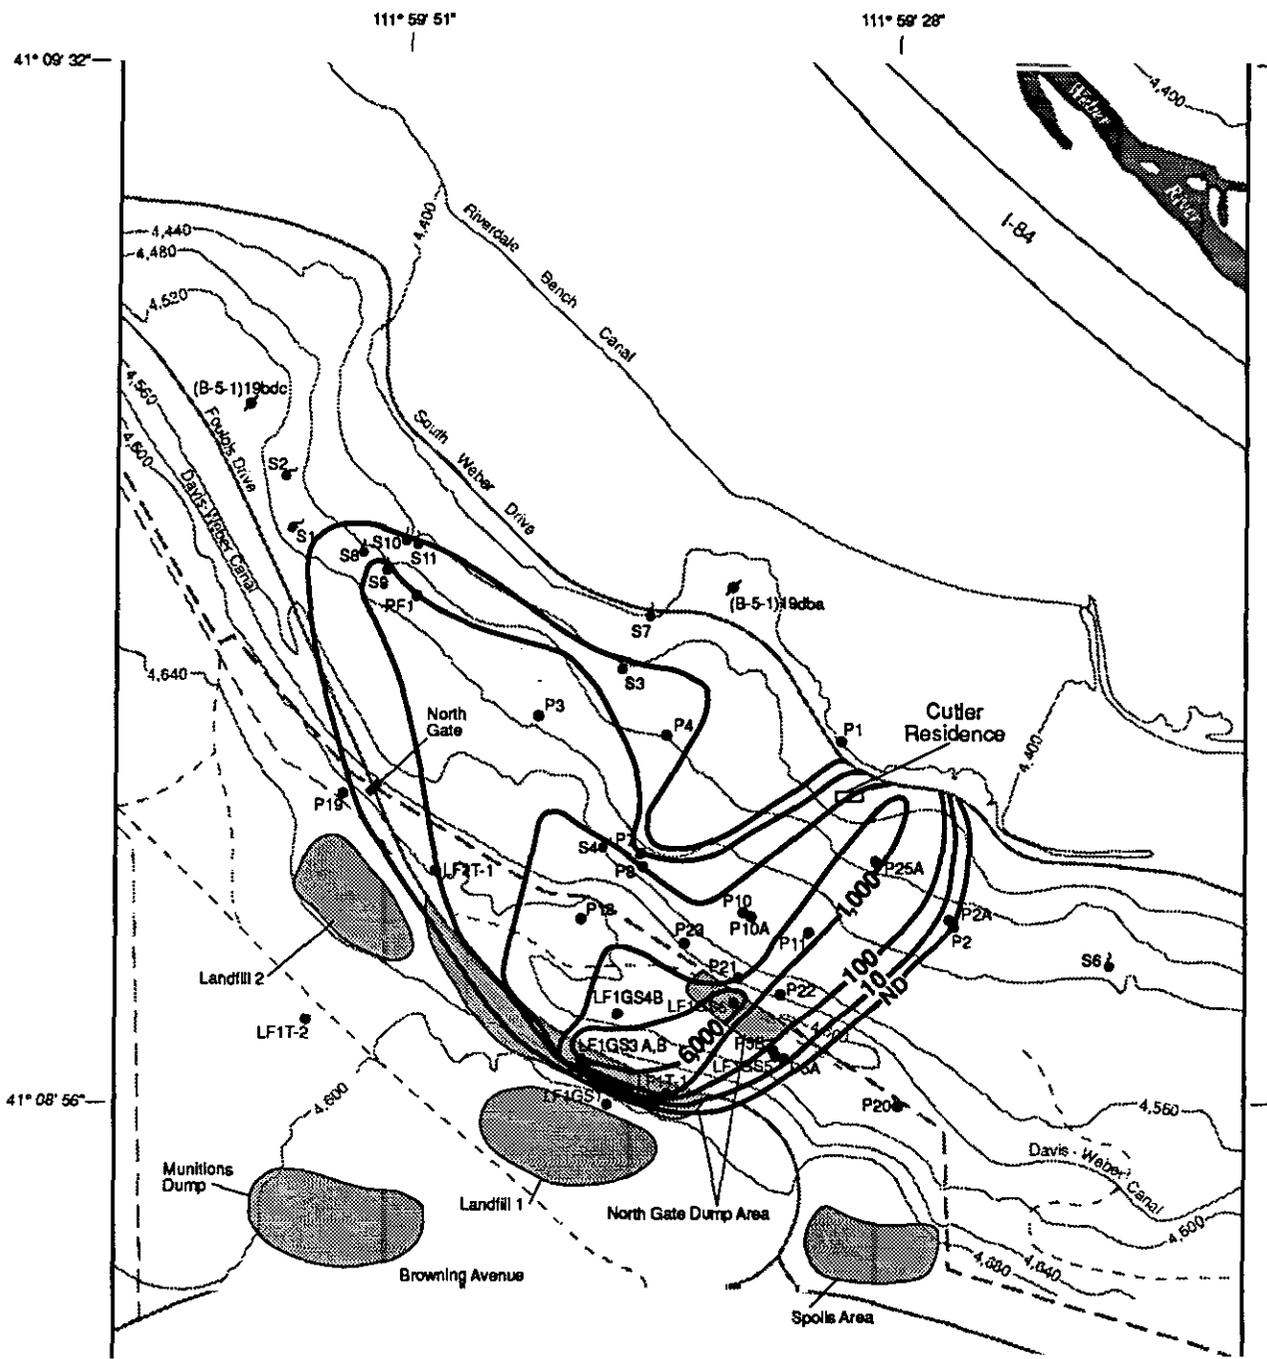
Figure ES-4.--Maximum concentrations of trichloroethylene in shallow ground water near Operable unit 4.

The southwesternmost (upgradient) occurrence of TCE noted during soil-gas surveys or in chemical analyses of water samples is immediately south of Foullois Drive at the north gate dump sites (fig. ES-4). Wells LF1T-1 and LF1GS3B, located along Foullois Drive about 300 ft apart, are believed to be in or near the most upgradient source area. The source of the contaminants observed in this area may be from roadside disposal and/or leakage from barrel storage. The largest concentration of TCE detected, 11,000 µg/L, was in water from well LF1GS6. It is not known if well LF1GS6 is in a separate disposal area or if the contaminants have migrated from the area near the upgradient well LF1T-1 down to well LF1GS6. It is possible that both wells are in or near separate disposal areas.

The largest concentration of TCE outside the boundary extends north from the north gate dump site near well LF1GS6. A narrow tongue of the plume containing between 1,000 and 5,000 $\mu\text{g/L}$ extends about 1,000 ft from well LF1GS6, downgradient to South Weber Drive. During March 1990, well LF1GS6 contained 11,000 $\mu\text{g/L}$ and well P25A, about 250 ft upgradient from South Weber Drive, contained 1,300 $\mu\text{g/L}$.

Inside the boundary of Hill AFB, the maximum concentration of TCE in ground water was about 11,000 $\mu\text{g/L}$, and outside the boundary the maximum was 2,800 $\mu\text{g/L}$ (blind duplicate sample contained 3,100 $\mu\text{g/L}$). Inside the boundary of Hill AFB the contaminated area is about 17 acres, and outside the boundary, it is about 40 acres (fig. ES-4).

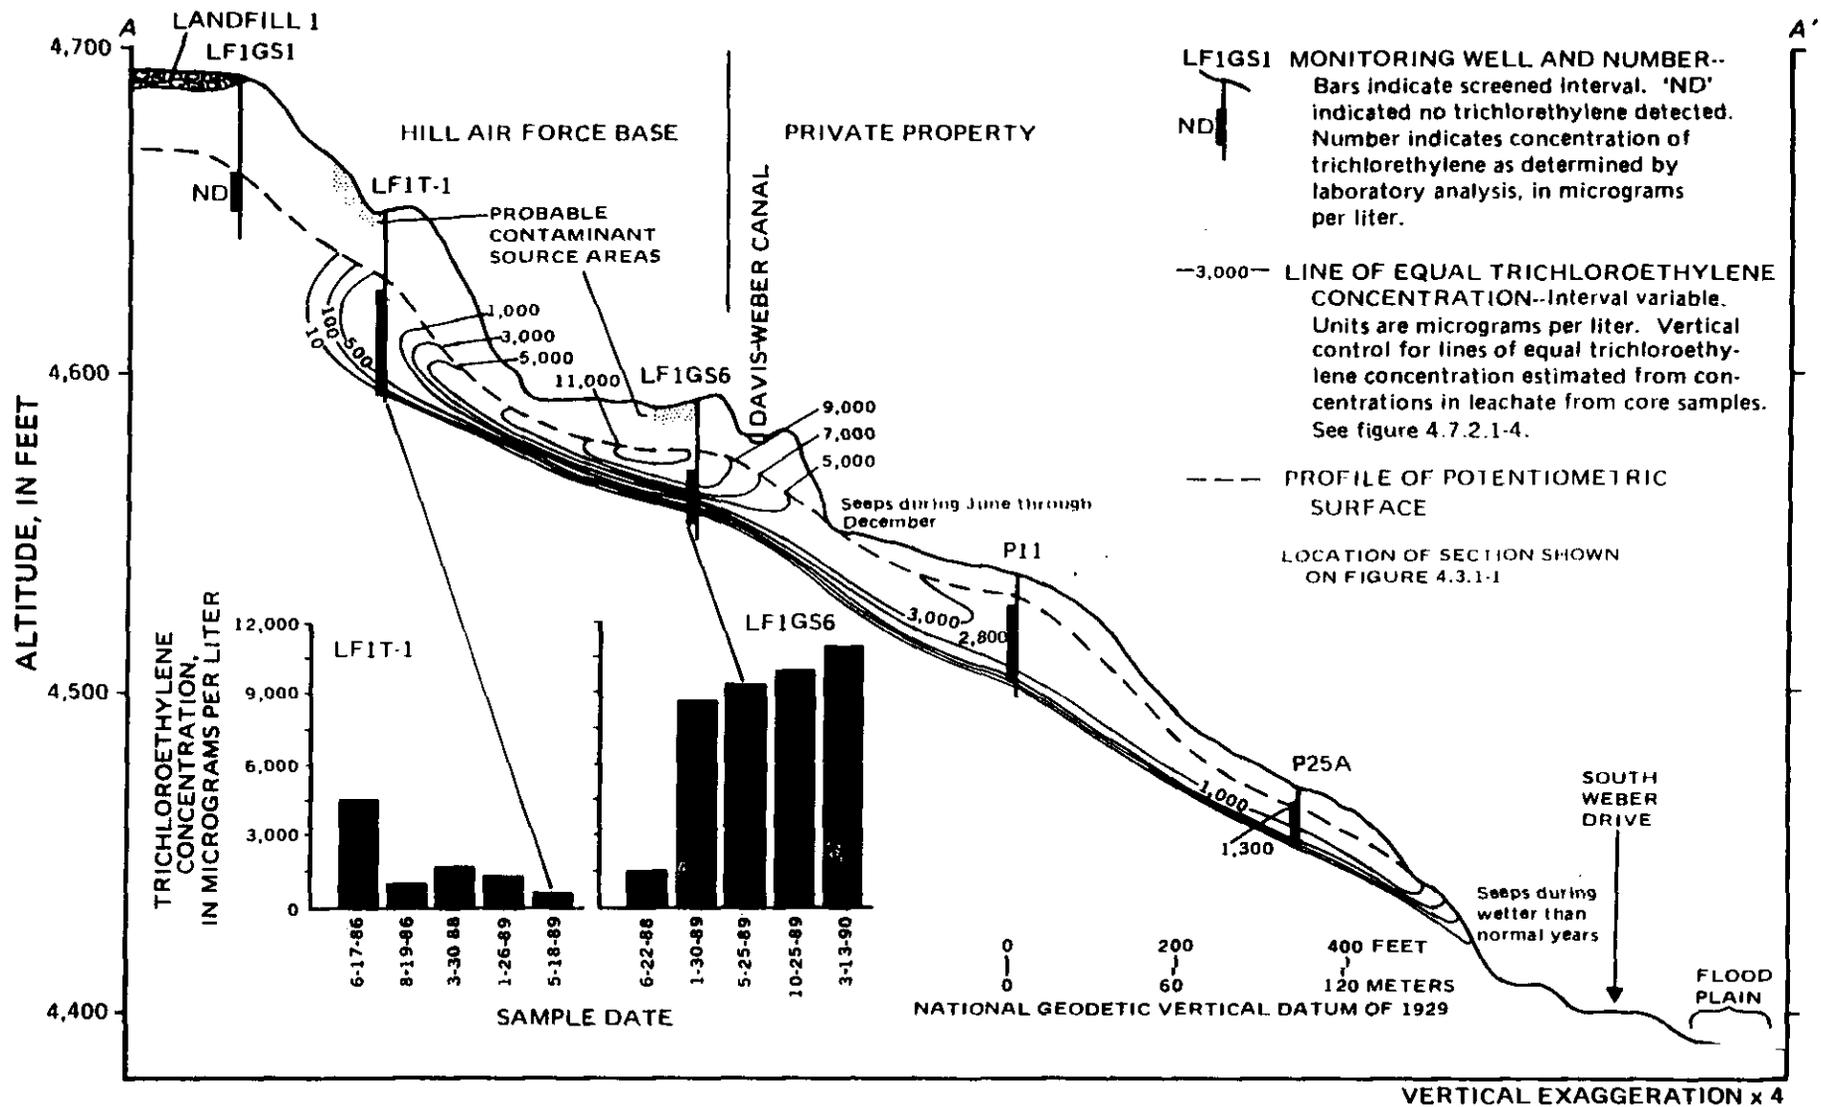
Figure ES-5--Vertical, lateral, and temporal variations of trichloroethylene concentrations in ground water along section A-A', 1986-90, in the area of Operable Unit 4.

Long term trends in the concentration may indicate that the plume is migrating past the site. Wells LF1GS3B, LF1GS4B, LF1GS6, LF1T-1, and LF2T-1 had sufficient analyses to describe trends of TCE concentrations since sampling began in 1986 (fig. ES-5). Of particular significance is the decreasing trend in the most upgradient well, LF1T-1, whereas the concentration in some of the wells farther downgradient are increasing. This suggests that the more concentrated part of the plume is moving from the most upgradient wells to the downgradient wells.

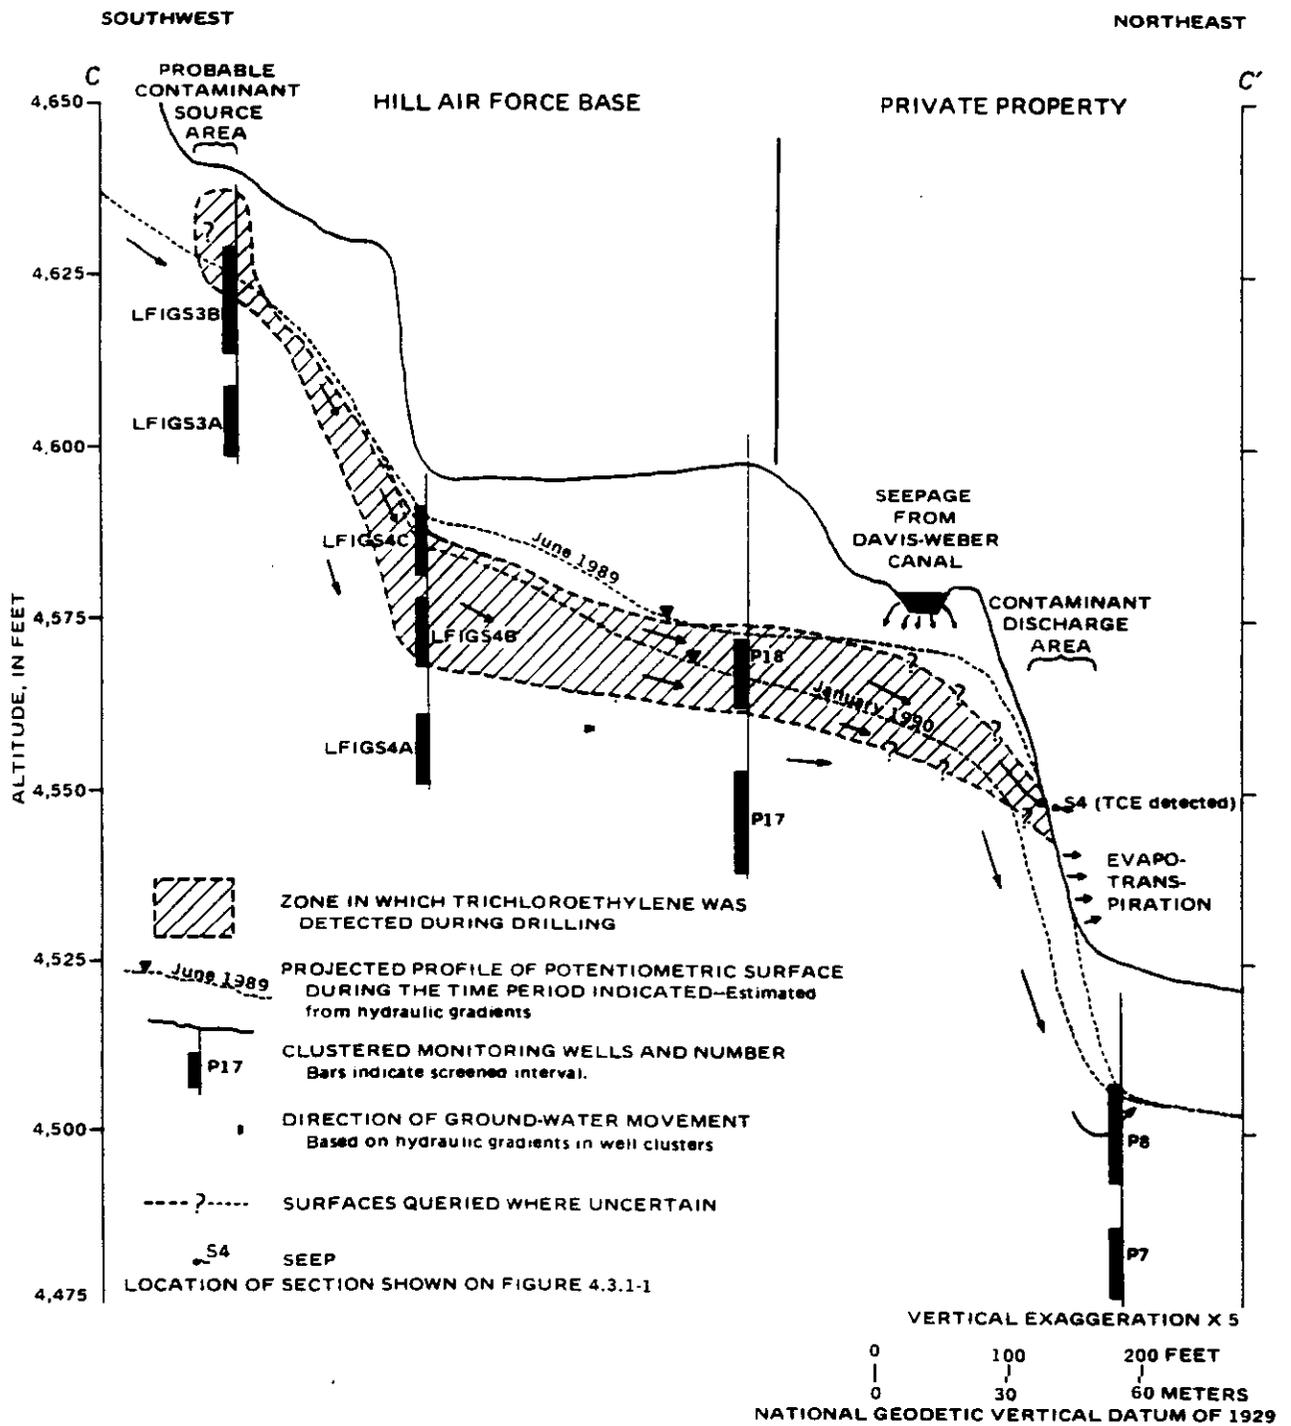
Figure ES-6.--Approximate movement of trichloroethylene along section C-C' from probable contaminant source to discharge location in the area of Operable Unit 4.

Hydraulic-head and chemical data from clusters of wells at four sites were used to construct an approximate flow path for contaminant migration from well LF1GS3B to the discharge area along the downgradient side of the canal bank (fig. ES-6). Along this approximate flow path, TCE is flushed from the unsaturated zone and upper few feet of the saturated zone near well LF1GS3B, migrates downgradient from well LF1GS3B into the saturated zones of wells LF1GS4B, LF1GS4C, and P18, and discharges along the downgradient side of the canal bank at seep S4. Some ground water is lost by evapotranspiration along the bank and TCE does not reach the cluster of wells, P7 and P8.
